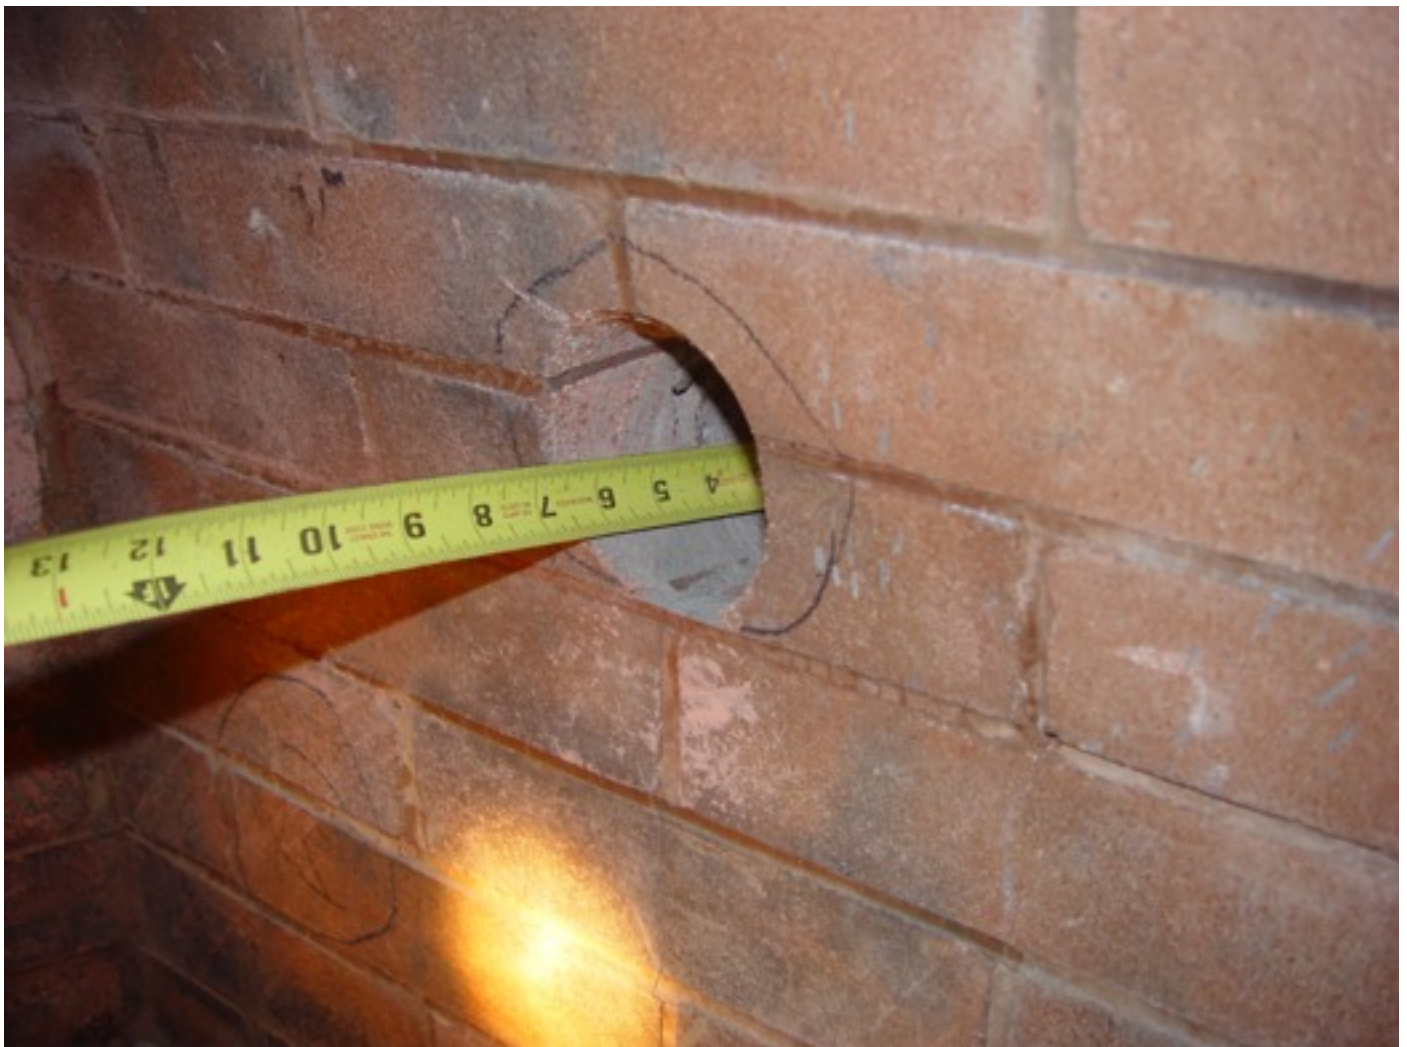
A. Wall Thickness: The rear wall of the firebox center rear wall (where a 4" hole was drilled for inspection) is a total of 6" thick as can be seen by the enclosed picture. The 2003 IBC states:

The firebox wall is not up to this standard.

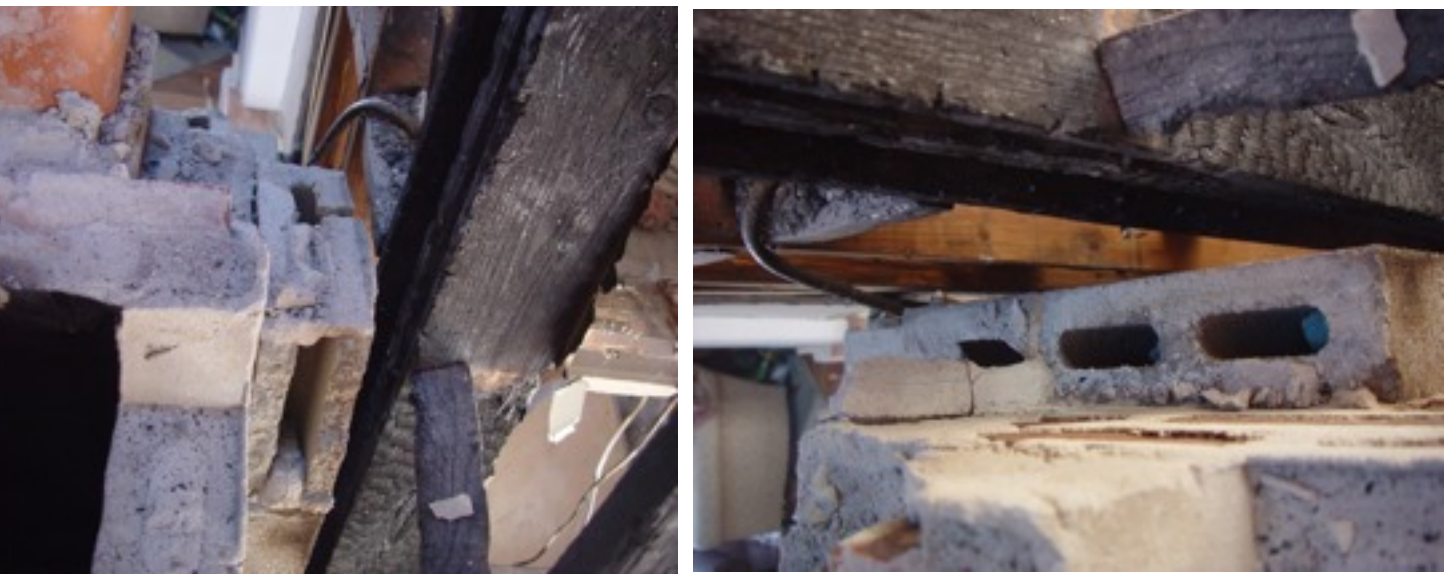
(Above- Hollow blocks used in rear wall construction)

B. Wall Construction: The same code paragraph above states that the 8" of masonry must be solid. In the case of 27 Locust Road, 4" ventilated (hollow) blocks were used and the voids were not filled.

#1A &B - Hollow masonry units of insufficient thickness

Heat from a fire flows in various ways, in this case mostly by radiant energy and by conduction through the masonry materials. Radiant energy can easily pass through air, which is one of the reasons the code specifies solid masonry units. This radiant energy, not unlike the rays of the sun, can overheat combustibles which are nearby, especially those that present a large surface area toward the source of the rays.

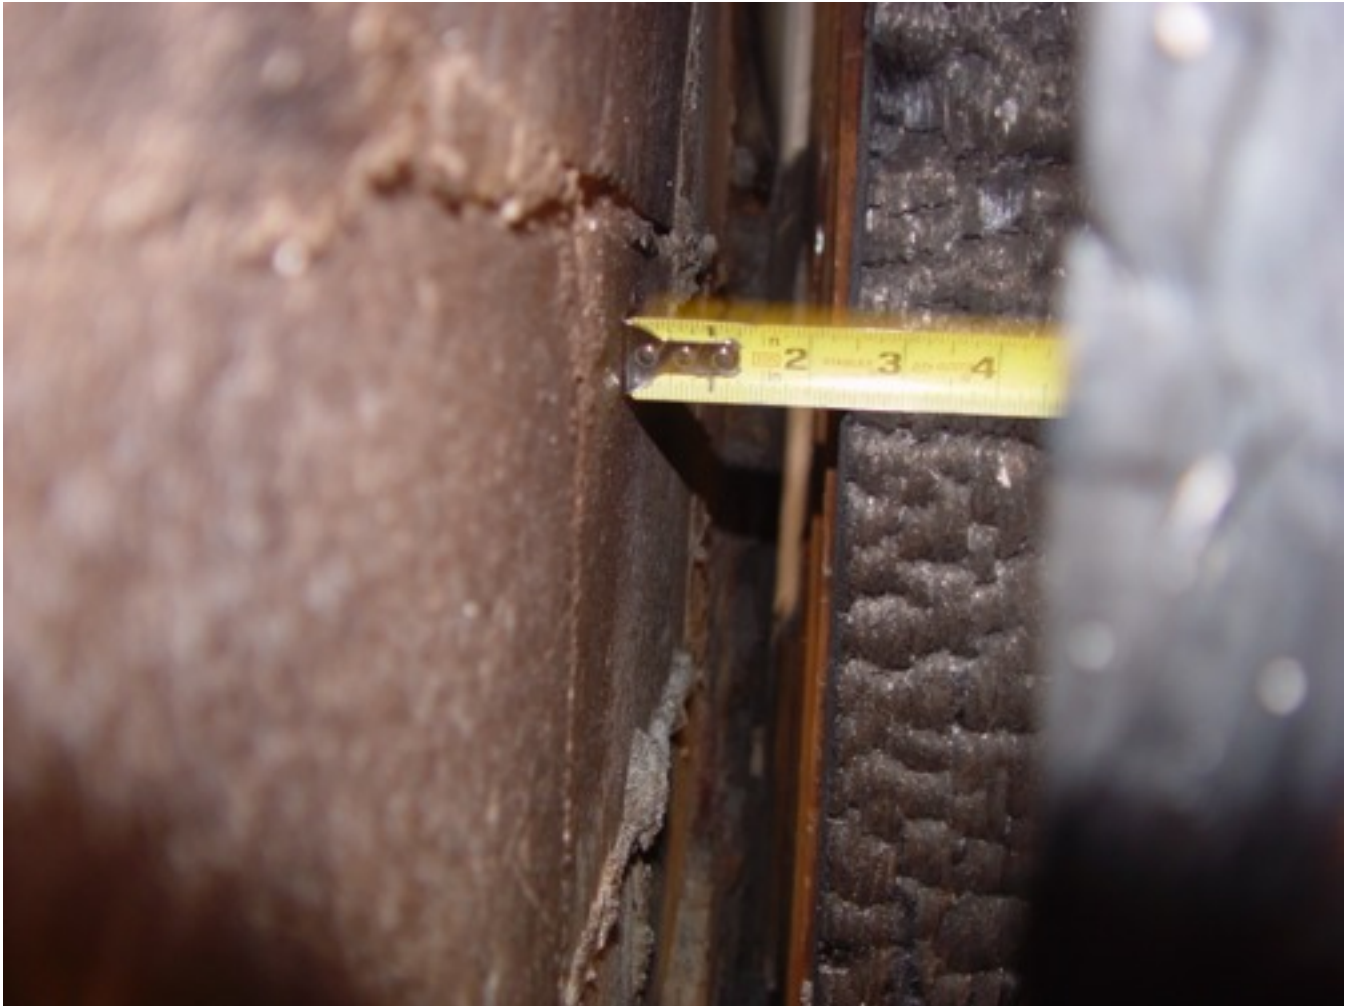
A. The studs behind the fireplace are approx. 2.25" from the code-deficient rear masonry wall of the fireplace. Again, according to the IBC:

(Above - distance from rear wall of fireplace to studs)

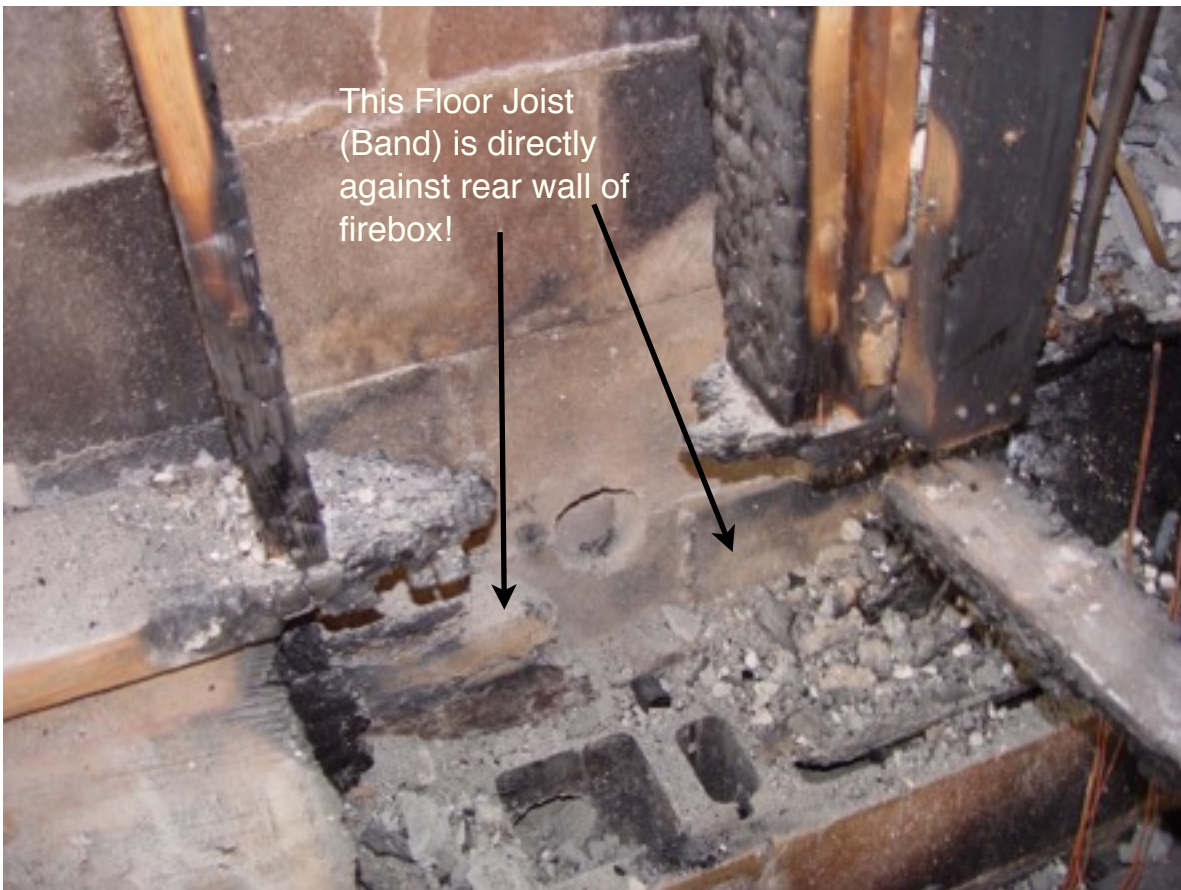
B. One of the floor framing members in the basement of the higher room (kitchen) was directly against the masonry of the fireplace. This area is clearly shown in the picture below with the arrows pointing to it.

#2B - framing member directly against rear wall of fireplace

In this case, because the room with the fireplace is a few feet lower than the room behind the fireplace, this meant that the framing member in question - which would usually be BELOW the fireplace level, was actually directly behind it. This 2x10 was directly against the masonry and could certainly combust from the direct radiant heat and conducted heat of a hot fire

Above shows fireplace from rear with 2x10 solid wood framing member directly against masonry firebox.

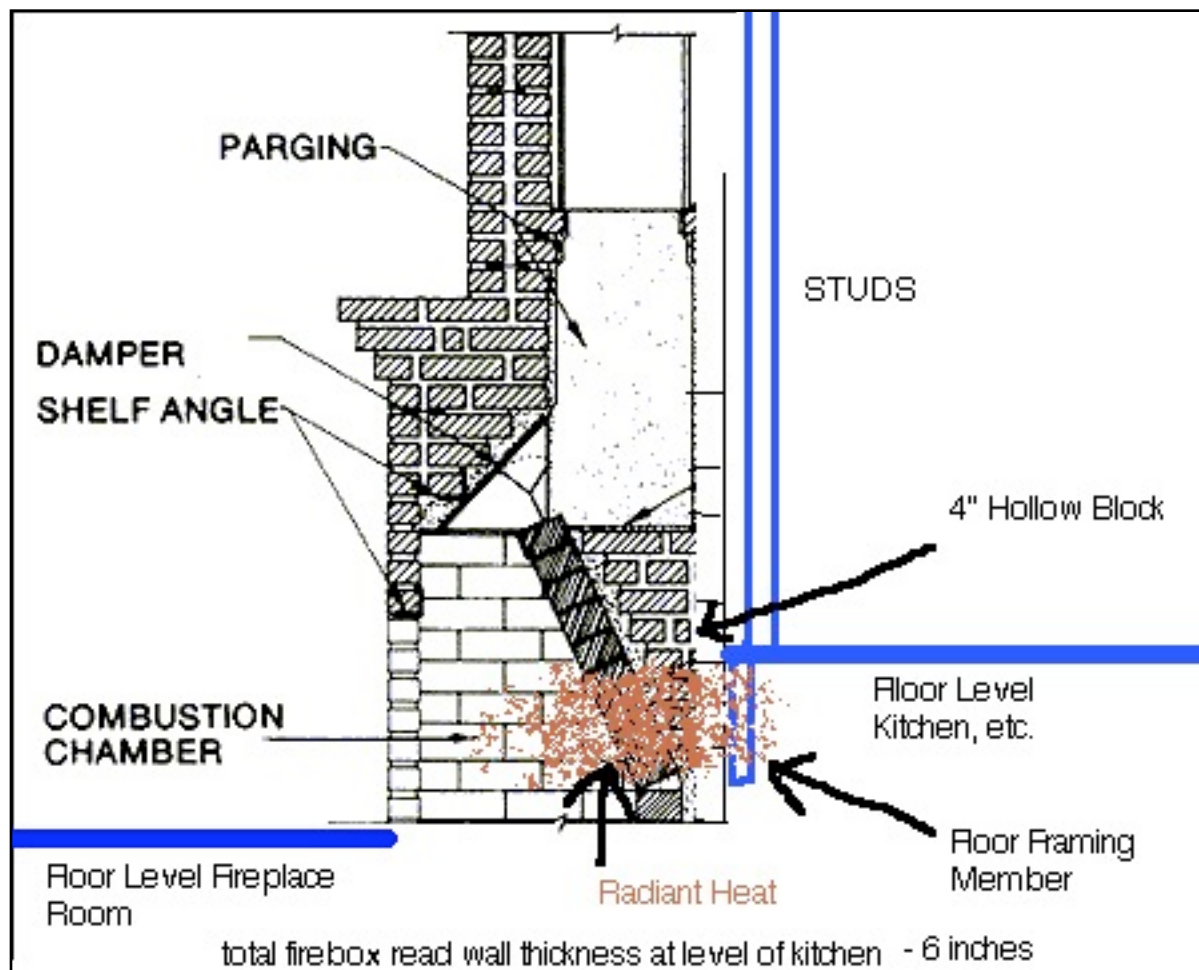
In summary, this fireplace was going to cause problems at some time, either now or in the future. In this case, the heavy use contributed to an almost immediate fire, while other scenarios might have taken years of the slow drying of the framing members. It is my opinion that the triggering factor in this case was the direct contact of framing members with the fireplace rear - which was made much worse in this case due to the offset in height of the two room - i.e., a framing member which would normally be located well below the fireplace burn area was now located directly behind it.

(Diagram above shows how radiant heat penetrated rear wall to combust floor framing)
