Masonry Chimney #1

Flue #1

Fireplace #1

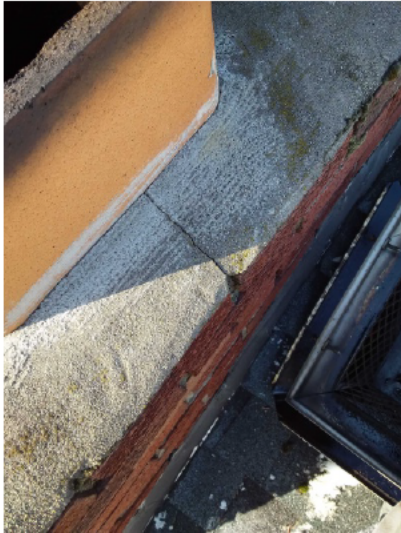
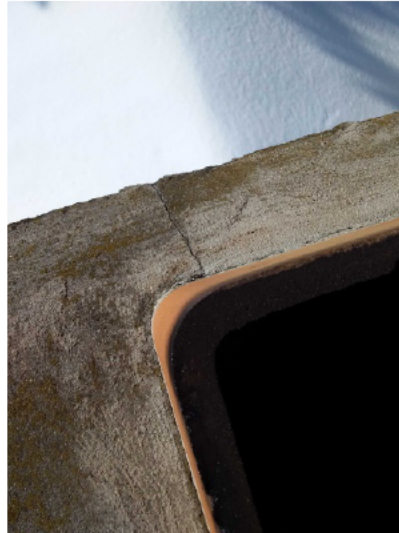
- **Crown / Wash cap:** Needs attention

The masonry work that protects the top of the chimney structure is deteriorated and no longer protects the chimney structure from water intrusion that will allow damage to the chimney structure and possibly the home

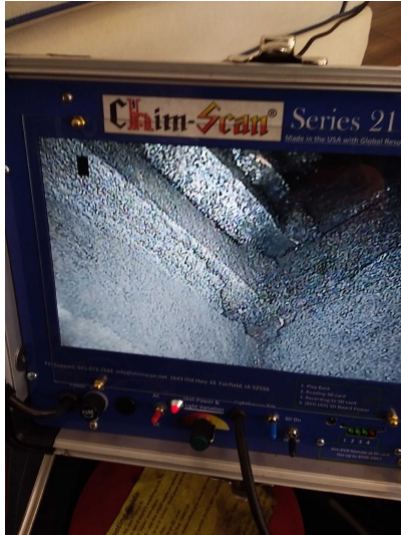
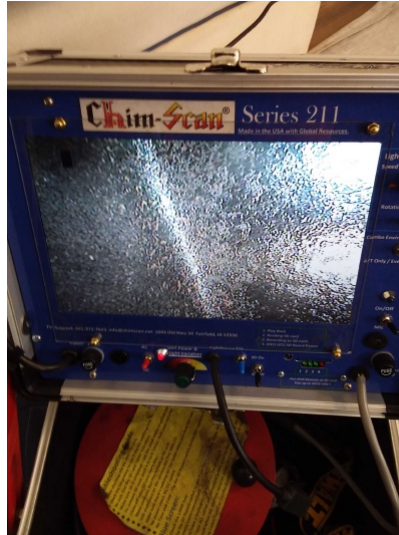
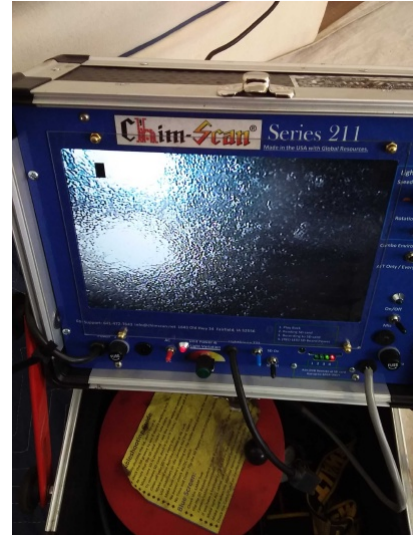
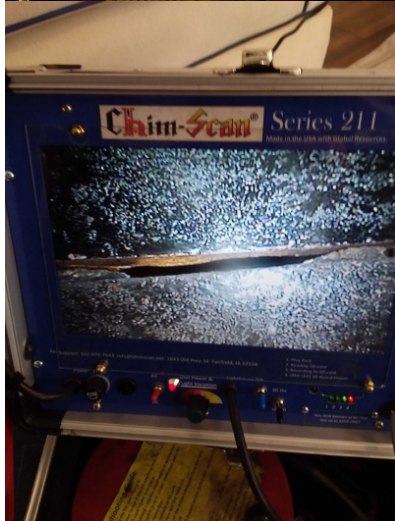
- **Appropriateness of the chimney liner type for the appliance:** Meets industry standards
- **Approximate flue length to appliance :** 15
- **Chimney liner / re-lining system support:** Meets industry standards
- **Level of cleanliness of venting system:** Potential hazard

Stage 3 Glazed Creosote: During the scan of your system we found stage 3 glazed creosote. Creosote goes through 3 stages. Stage 1 being a very fine brown powder like stage. If the system is not swept or undergoes heavy use it will become Stage 2. Stage 2 Creosote is a black flakey substance often with crystallizing taking place. If Stage 2 creosote is left in the system the crystallization will transform into a sticky tar like substance with a very shiny appearance. This is Stage 3 Glazed Creosote; it is a combustible material and can catch fire if the right amount of air is allowed to find its way into the flue during use. Removing Stage 3 Creosote may require chemicals and or more aggressive forms of cleaning than standard cleaning procedures. It should be removed before further use.

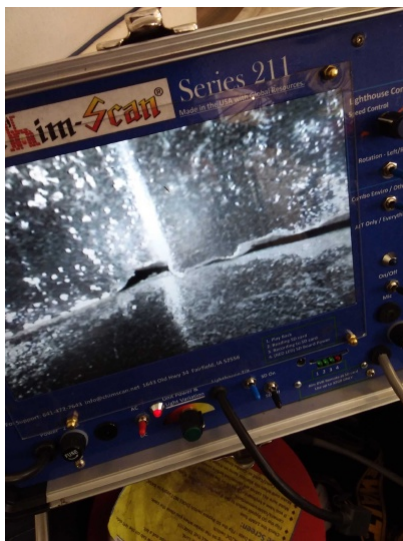
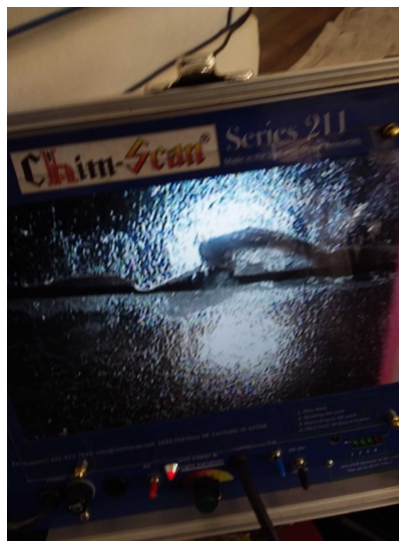
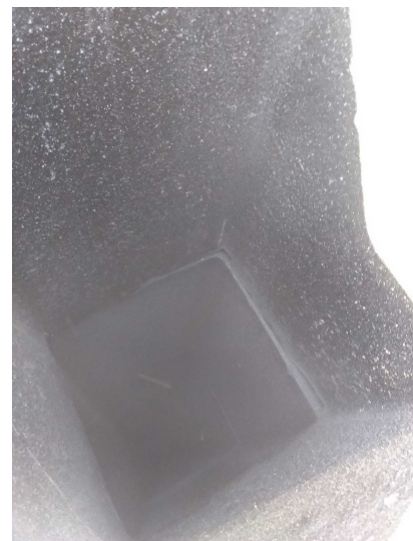
- **Internal flue opening length: 11.25**
- **Chimney cap / spark guard / Top damper: Suitable material condition**
- **Chimney liner presence, condition regarding readily visible defects, holes, cracks, missing mortar joints, spalling, mortar protrusions, and proper alignment: Potential hazard**

The mortar joints between the flue tiles are no longer intact. These missing or deteriorated mortar joints prevent the flue tiles from properly conveying the byproducts of combustion to the exterior of the home.

Flue is coated with stage 3 glazed creosote.

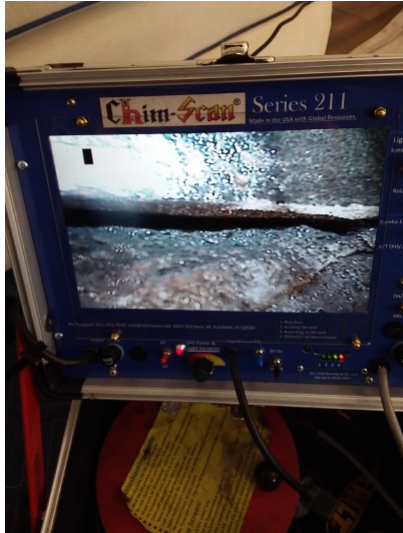
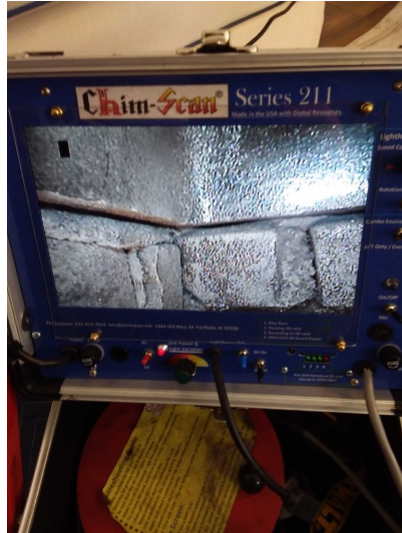
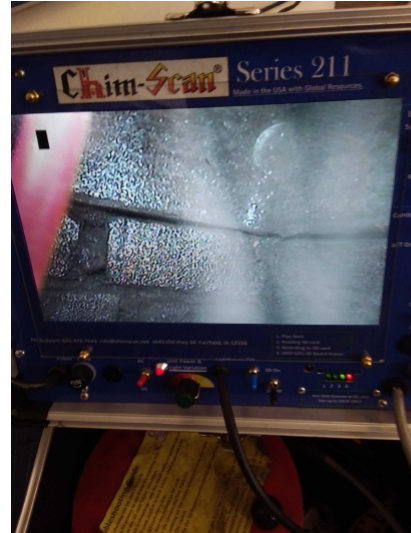
- Hearth extension size - sides of fireplace: 20
- Flue tile sealed at smoke chamber: Does not meet industry standards

The flue tile is not sealed at the top of the smoke chamber. This can allow the byproducts of combustion to go behind the flue tiles and may migrate to areas of the chimney and home not meant to contain them. The potential hazard exists that combustible residue could built up where it cannot be maintained and allow the possibility of a structure fire. This defect could also allow carbon monoxide the enter the home. 2016 NFPA 211 11.2.1.13

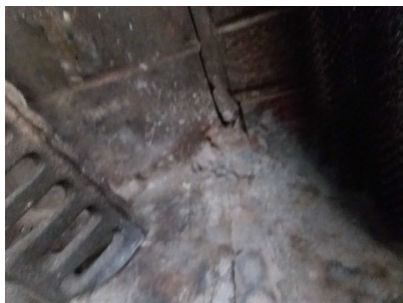
- **The firebox is required to have tight fitting joints at the facing material, lintel and hearth extension:** Needs attention

There are cracks evident where the face of the fireplace meets the firebox. These cracks have the potential hazard of allowing heat, sparks and other byproducts of combustion to travel behind the facing material of the fireplace and possibly cause a structural fire. 2016 NFPA 211 11.2.1.5

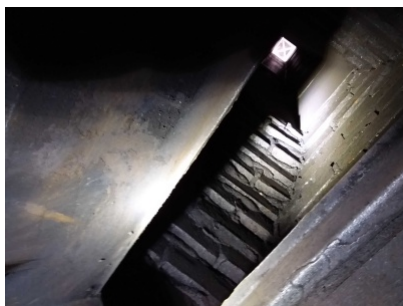
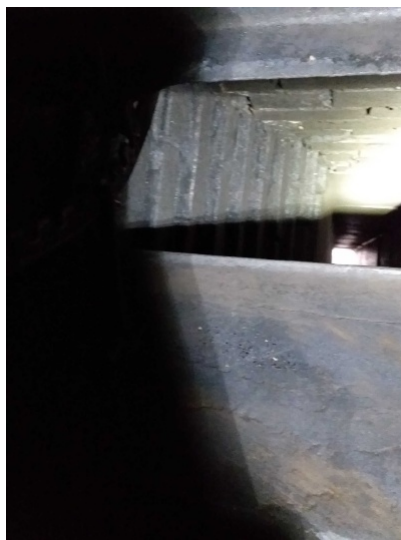
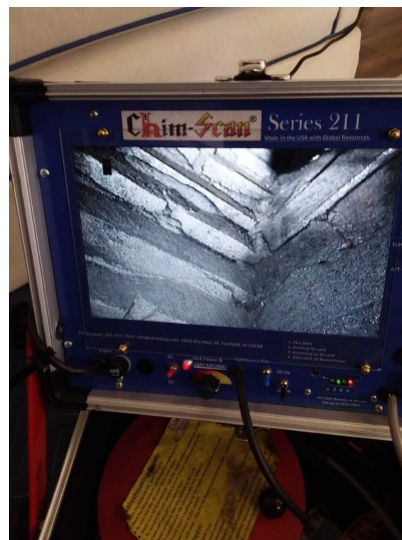
- **Firebox depth: 25**
- **Blockage or significant obstructions in damper and smoke chamber area:** Needs attention

The area above the damper is restricted by construction materials. Even when the damper is fully open the path for the smoke to travel is diminished and the fireplace may not draft properly. 2016 NFPA 11.2.1.3.3 IRC 2006 2111.6

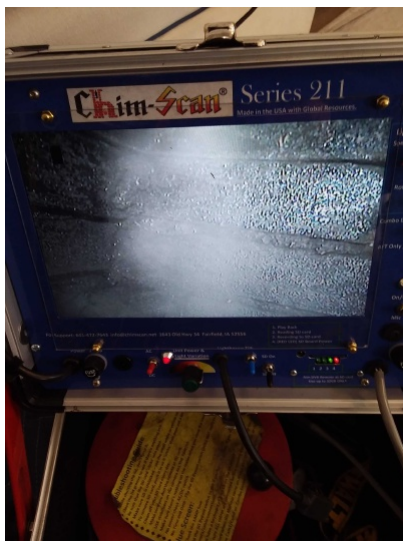
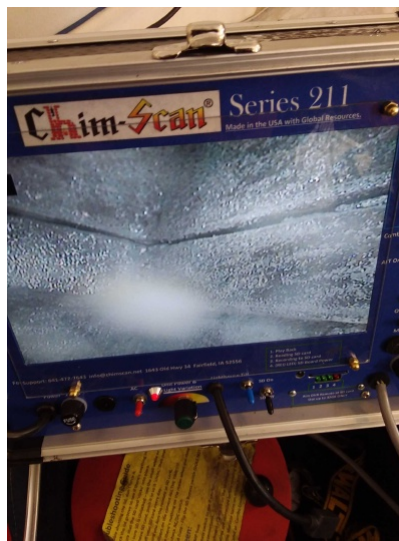
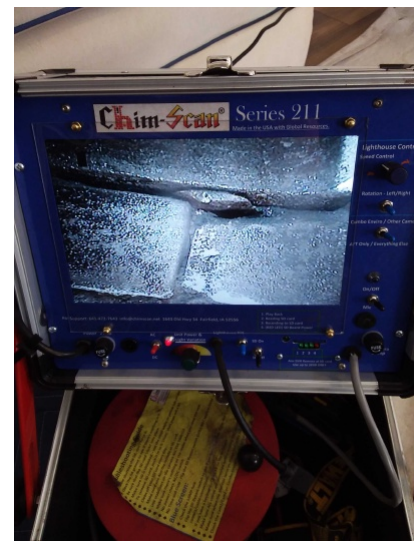
The smoke chamber is a crucial part of the fireplace system and is often the most poorly constructed area of the structure. Most structural fires associated with fireplaces originate in this area. It is imperative that this area be completely sealed and parged smooth. 2016 NFPA 211 11.2.1.13 IRC 2006 2111.S

The smoke chamber walls are not parged smooth. This can cause a chimney to draft poorly. Lack of the parging material may also increase the risk of a structural fire and the risk of the byproducts of combustion migrating into the home. 2016 NFPA 211 11.2.1.13 IRC 2006 2111.S

Smoke chamber is coated with stage 3 glazed creosote.

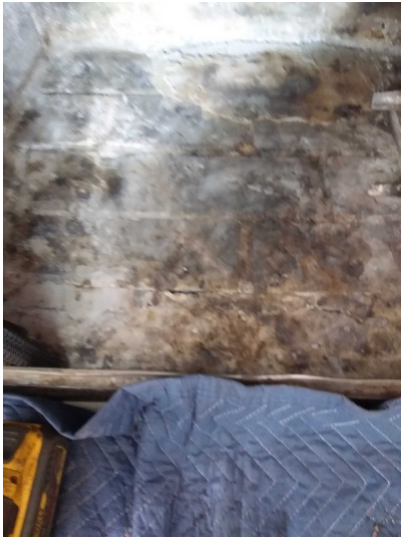
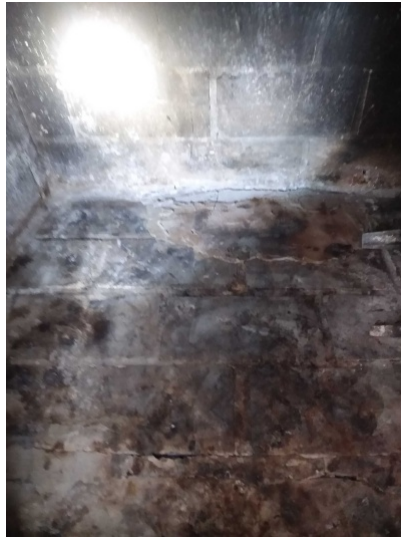
- **General condition of hearth and hearth extension:** Does not meet industry standards

The floor of the firebox has cracks in the mortar and / or bricks or the bricks are pitted. The floor of the firebox needs repaired.

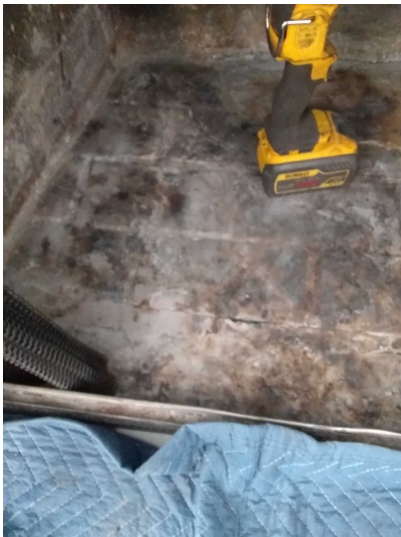
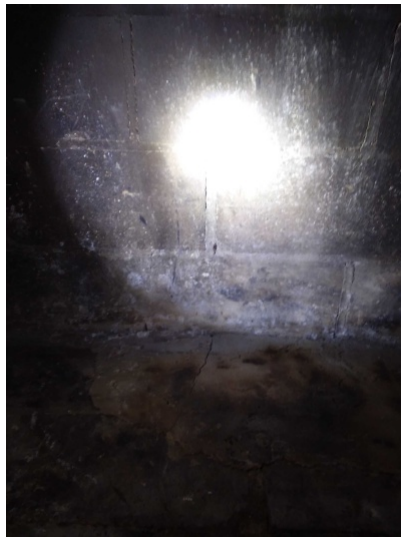
- **Hearth extension size measured starting at the face of the fireplace:** 15
- **General condition of the firebox:** Needs attention

There are gaps in the mortar joints. The smallest gap in the masonry can create a pathway for rogue flue gases to be drawn into areas of the structure that could pose a potential fire or carbon monoxide threat. Fireboxes are to be laid with refractory mortar that can withstand heat and moisture. 2016 NFPA 211 11.2.1.4 IRC 2006 2111.5
