INSPECTION REPORT

Date of Inspection: 12/30/2022 12:20 PM

Level of Inspection: NFPA Level1

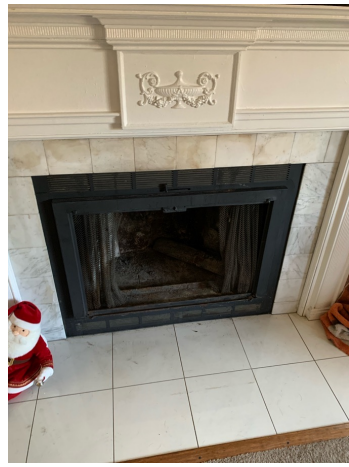
Prefabricated fireplace

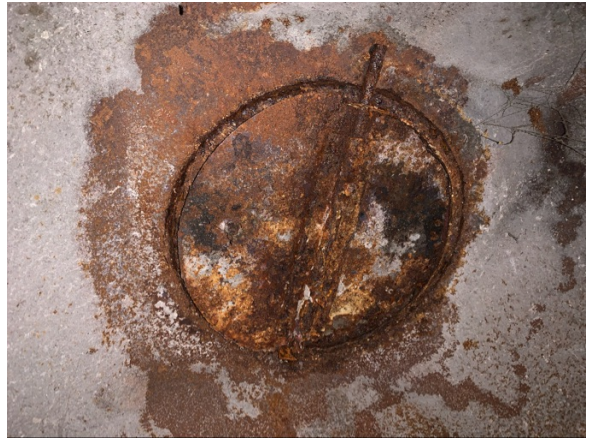
Corroded/ rusted damper / seized

- There are several areas of the fireplace that are starting to rust. This is a potential hazard as the rust will fatigue the metal. The fireplace has met its life expectancy and is no longer suitable for use.
- The damper shows signs of water/moisture entry and has rust and/or corrosion. Rust fatigues the metal and renders the system unsuitable for use.
- Panels have cracks and/or are broken / warped . Can not contain heat properly inside firebox , This renders the system unsuitable for use.

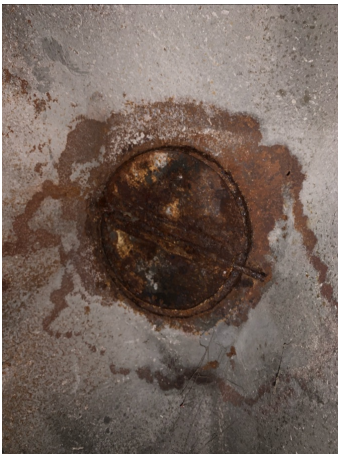
No scan preformed due to conditions of damper, etc

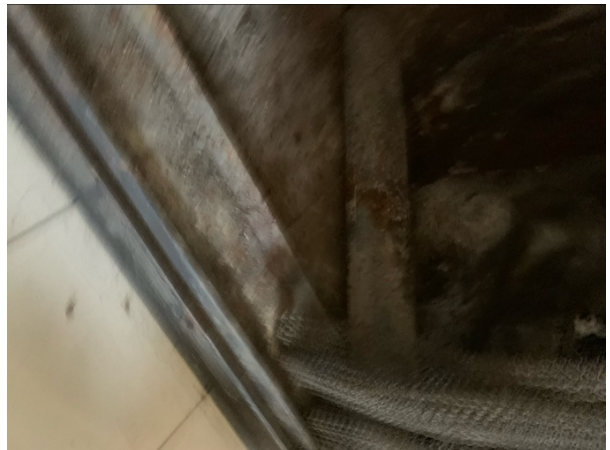
Firebox has multiple warped walls

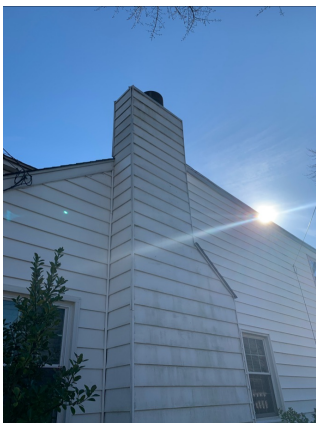
Vinyl exterior

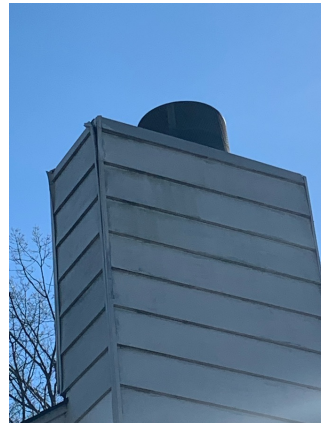
Chase lifting
