Inspection Address: ~~123456789 Dr~~
Inspection Date: ~~March 15, 2022~~

Flue

Main Floor Fireplace

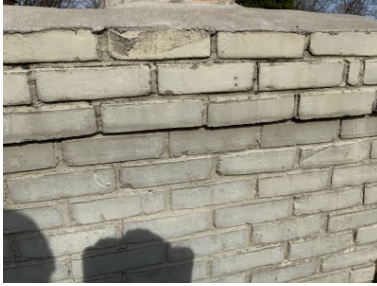
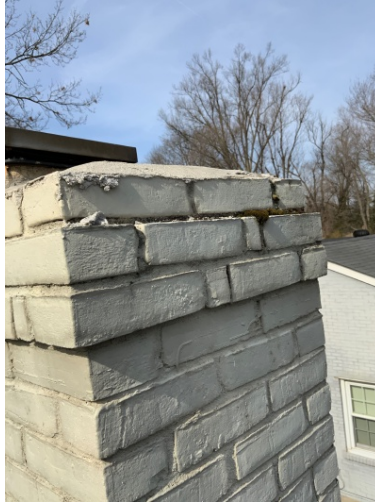
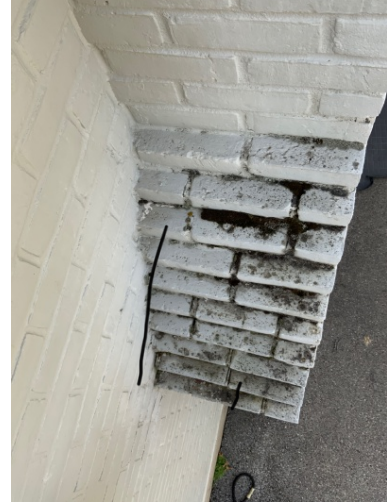
There is significant deterioration in the mortar between the bricks. This can not only allow water intrusion into the chimney and cause potential leaks inside the home, but it also allows water into the chimney which can damage the chimney structure.

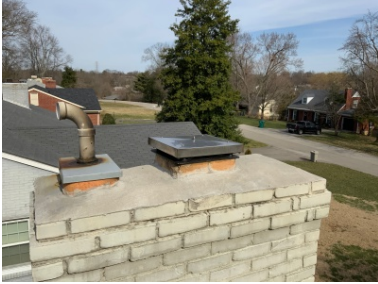
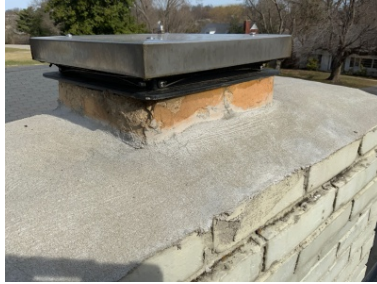
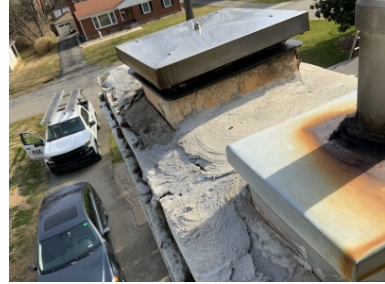
• **Crown / Wash cap:** Deteriorated

The crown / wash cap of the chimney is not constructed in a way that properly protects the chimney. The crown should be constructed with concrete. It must have an expansion joint around the flue tile. It should overhang the main structure to allow a drip edge to protect the chimney. A properly made crown will help protect the chimney from water intrusion and damage.

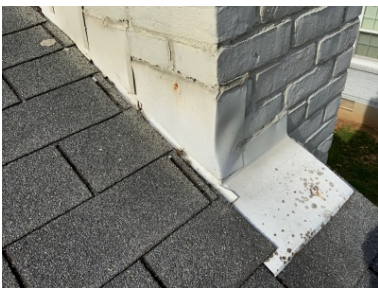
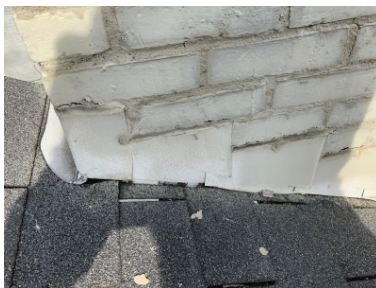
• **Flashing:** Needs attention

Flashing sealant needs to be replaced

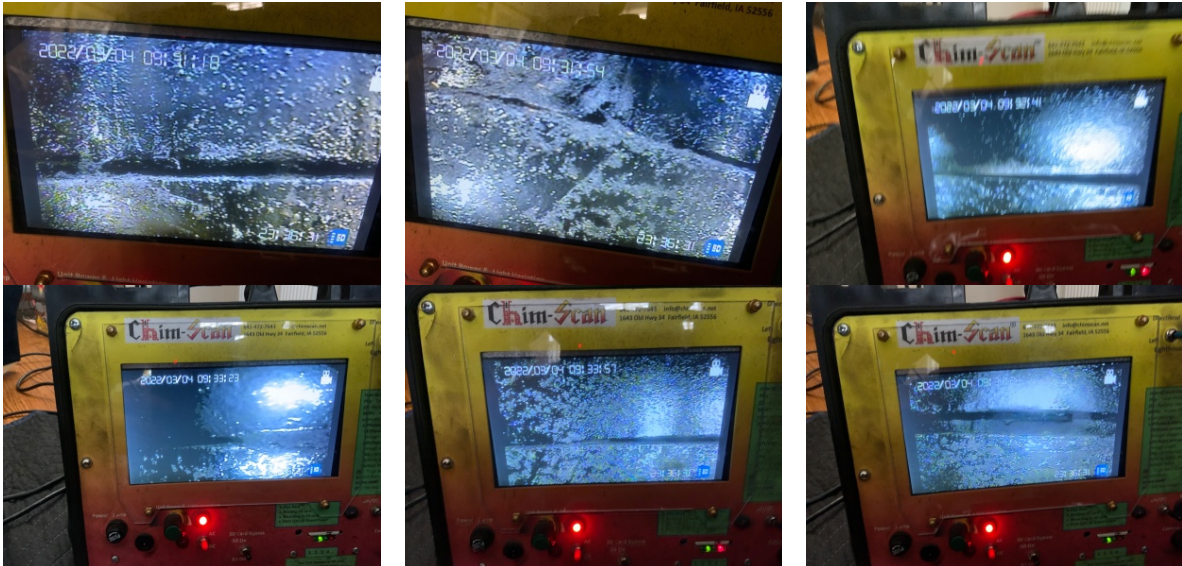
- Chimney liner presence, condition regarding readily visible defects, holes, cracks, missing mortar joints, spalling, mortar protrusions, and proper alignment: Deteriorated

There are tiles that have vertical cracks. Vertical cracks are an indication that there has been a sudden rapid heating of the tile. This rapid heating causes thermal shock to the tile. Thermal shock causes the inside of the tile to heat more rapidly than the exterior of the tile. Heat causes the inside of the tile to expand more rapidly than the exterior of the tile. When this occurs the tile will crack vertically. This flue tile can no longer perform its intended function. The chimney must be relined. 2016 NFPA 211 14.9

The mortar joints between the flue tiles are no longer intact. These missing or deteriorated mortar joints prevent the flue tiles from properly conveying the byproducts of combustion to the exterior of the home.

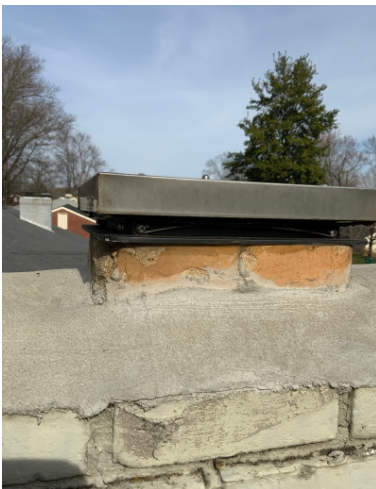
- Height of liner above crown: Needs attention

The flue tile has the proper height, but it is currently deteriorated and needs to be replaced.

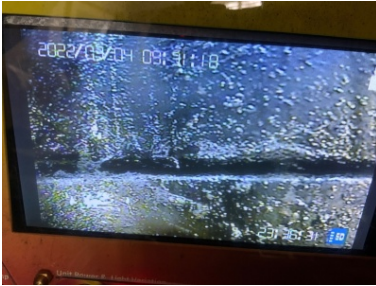
- **Level of cleanliness of venting system:** Does not meet industry standards

The flue is coated in creosote and soot. This could be the fuel that would lead to a flue fire. 2016 NFPA 211 7.2.13.3

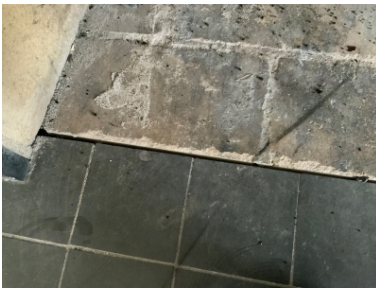
- **General condition of hearth and hearth extension:** Deteriorated

There is a gap between the hearth and hearth extension. Sparks and embers can fall through the crack posing a potential risk.

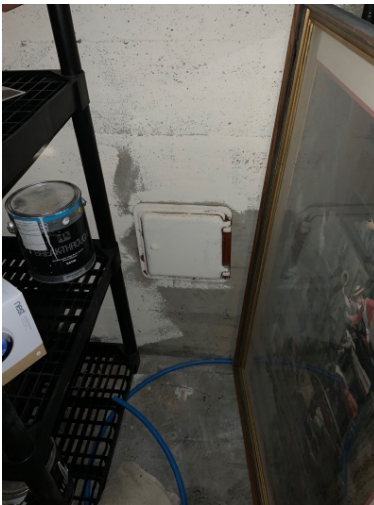
- **Fireplace width: 36**
32 rear
- **Clearance to combustible trim: 7**
5" sides
- **Ash pit clean out door (condition and clearance to combustibles): Potential hazard**

There are combustible materials that are too close to the ash cleanout door. This could potentially be a fire hazard. The Clearance to combustibles is to be 18" 2016 NFPA 211 7.1.4.5 IRC 2006

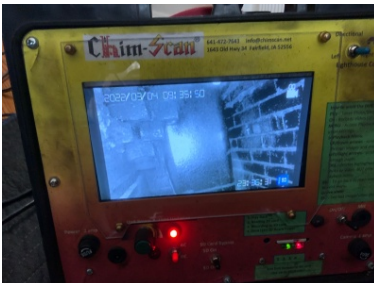
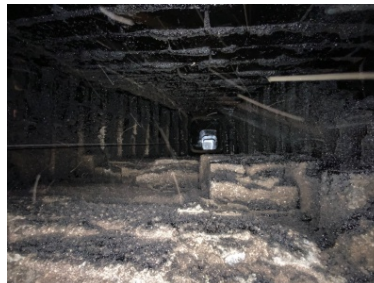
- **Smoke chamber general accessibility, construction, parging and condition: Does not meet industry standards**

The smoke chamber is a crucial part of the fireplace system and is often the most poorly constructed area of the structure. Most structural fires associated with fireplaces originate in this area. It is imperative that this area be completely sealed and parged smooth. 2016 NFPA 211 11.2.1.13 IRC 2006 2111.S

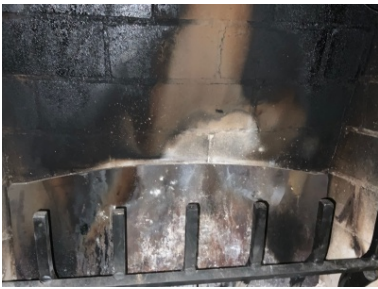
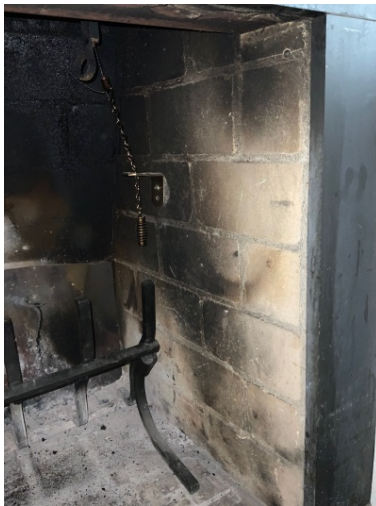
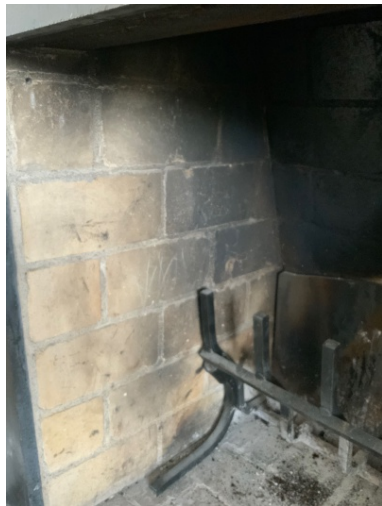
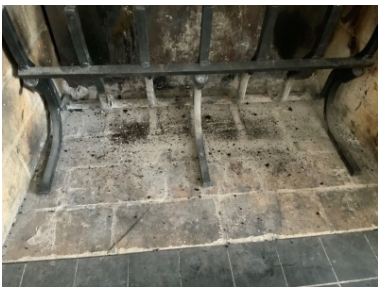
• **General condition of the firebox: Deteriorated**

The firebox has deteriorated mortar joints. Firebrick are to be laid with a medium-duty refractory mortar. The width of the joints in the firebox should not exceed 1/4". 2016 NFPA 211 11.2.1.4 IRC 2006 2111.5

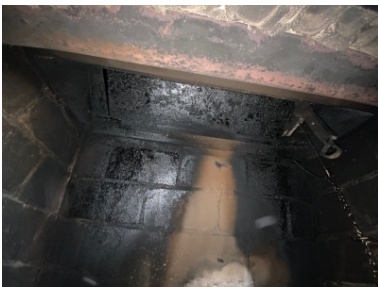
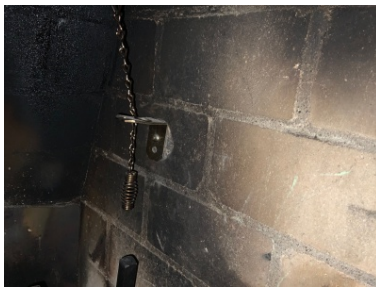
• **Operation and closure of the damper assembly: Needs attention**

The fireplace has 2 working dampers. The fireplace must only have 1 operating damper for safety.
