Power Equipment Service Bulletin 2007002

SUBJECT: GX Fuel Cap doesn't Vent When Saturated

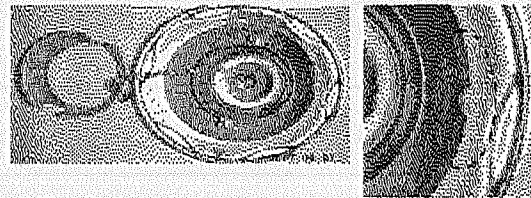
Old Style Cap New Style Cap

It has come to our attention that some of the new style (low evaporative emission) chromed and carbon canister filled fuel cap, may have the breather blocked.

Blockage may occur if the fuel tank is overfilled and/or the engine is tipped on large angles during loading and/or transportation.

According to our analysis, the cause is a combination of fuel blocking the breather in the new style fuel caps and tight tolerances between the cap outer and the canister.

Please advise your customers to not over fill the fuel tank. There is an insert that is attached to the fuel cap that acts as maximum fill level indicator. This is detailed in the Owner's Manual. Fuel should not be above the lower level of this insert.

There is also a replacement cap available. It can be identified by 2 small dents in the top of the cap or a small notch out of the rubber seal. Part number is 17620-Z4H-010.
