Technical Data Sheet

Heritage Model 8024 Primary Air Shutter Repair Kit

Kit Number 90-49205

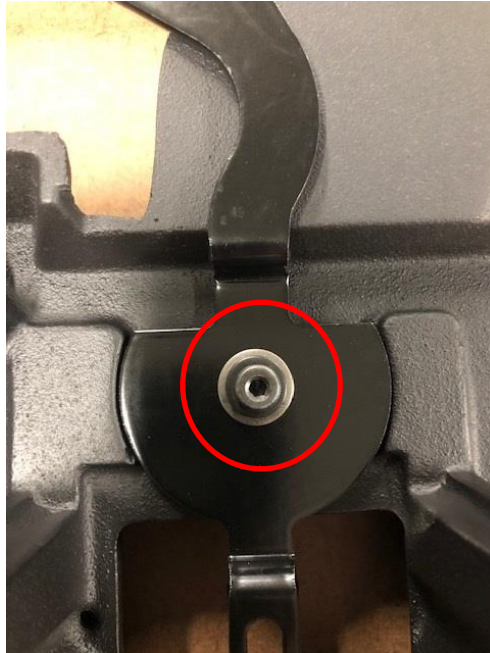
Figure 2

- 2) Using a 1/8" Allen Wrench, remove the single bolt holding the primary air control assembly. Take note of the spacer orientation. The primary air control handle can now be removed from the stove.

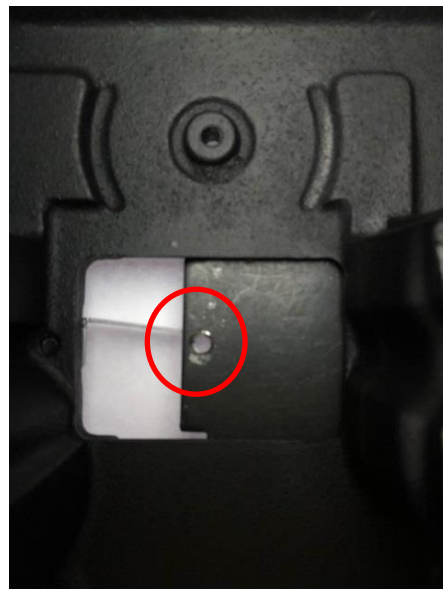
Figure 3

- 3) You now have access to the broken air shutter. There will be a small hole in the air shutter, where the pin normally would be. This hole needs to be drilled/tapped to 10-24.

- 4) Using a right angle drill-with a #25 drill bit, drill the air shutter in the existing hole. There is a strap on the top side of the shutter that will hold the shutter in place.
- 5) The new hole can now be tapped. With a 10-24 thru tap in a hand tap wrench, carefully tap the hole. Work the tap back and forth to cut the threads, and keep the tap from breaking.

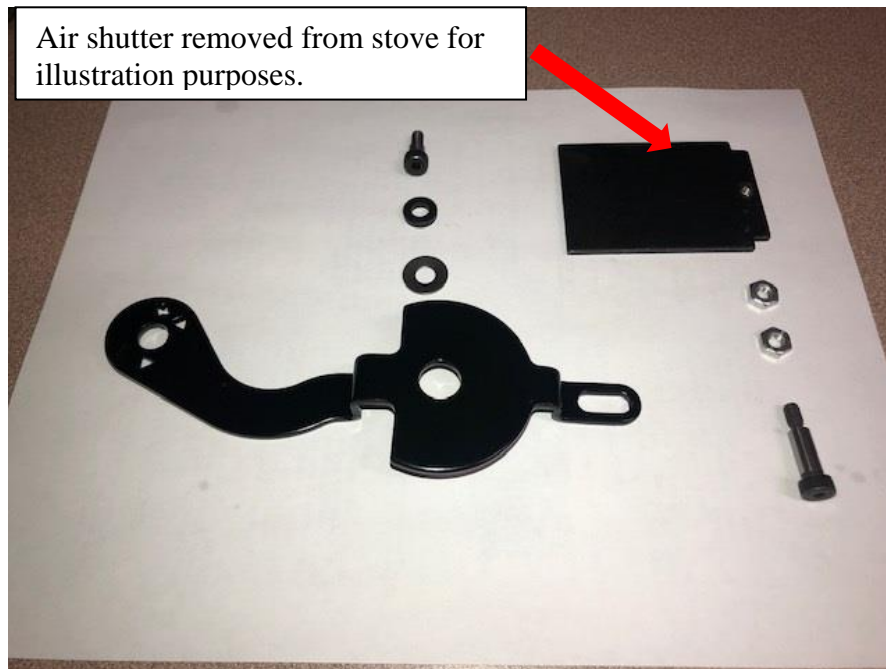
- 6) You can now assemble the air control with the new components, before reinstalling it into the stove. Figure 4 shows the correct order of components.

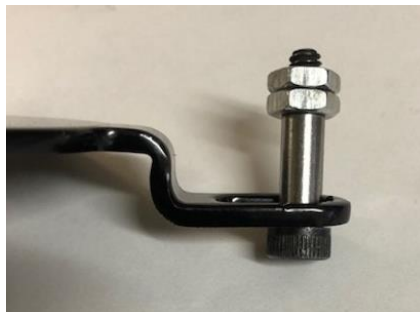
Figure 5

- 7) Insert the new shoulder bolt through the primary air control handle slot, as shown in figure 5. Double nut the shoulder bolt with the included nuts. Tighten the nuts using a 3/8" wrench. **Optional:** Apply a small drop of lock-tite to the remaining threads.

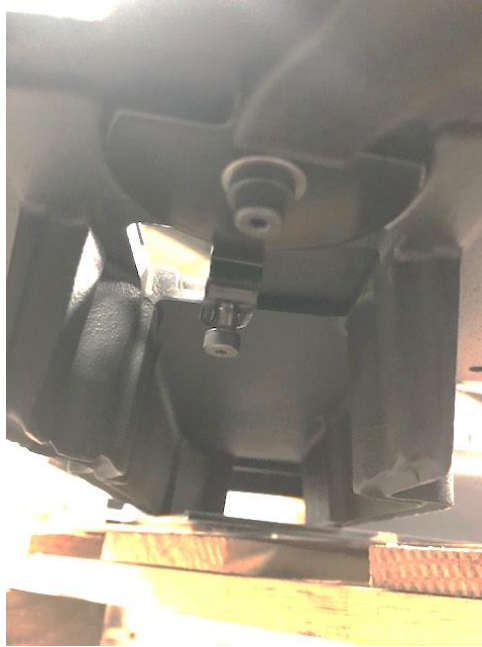
Figure 6

- 8) Reinstall the primary air control handle onto the stove, as shown in figure 6. Tighten the shoulder bolt with a 1/8" Allen wrench.

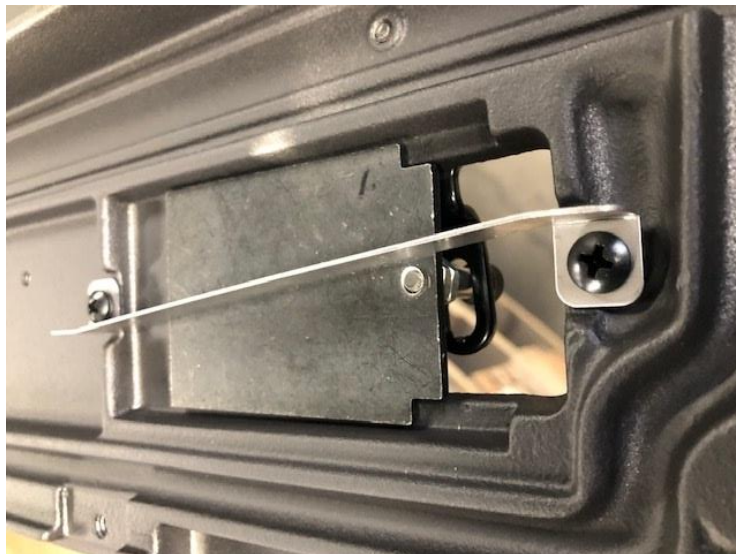
- 9) Thread the shoulder bolt into the newly drilled/tapped hole. Tighten with 1/8" Allen Wrench. Figure 7 shows the detail of the top side of the shutter. This is not visible when completing this repair.
