Masonry Chimney #1

Flue #1

Fireplace #1

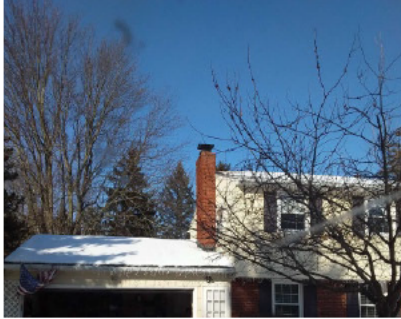
- **Crown / Wash cap:** Needs attention

The masonry work that protects the top of the chimney structure is deteriorated and no longer protects the chimney structure from water intrusion that will allow damage to the chimney structure and possibly the home

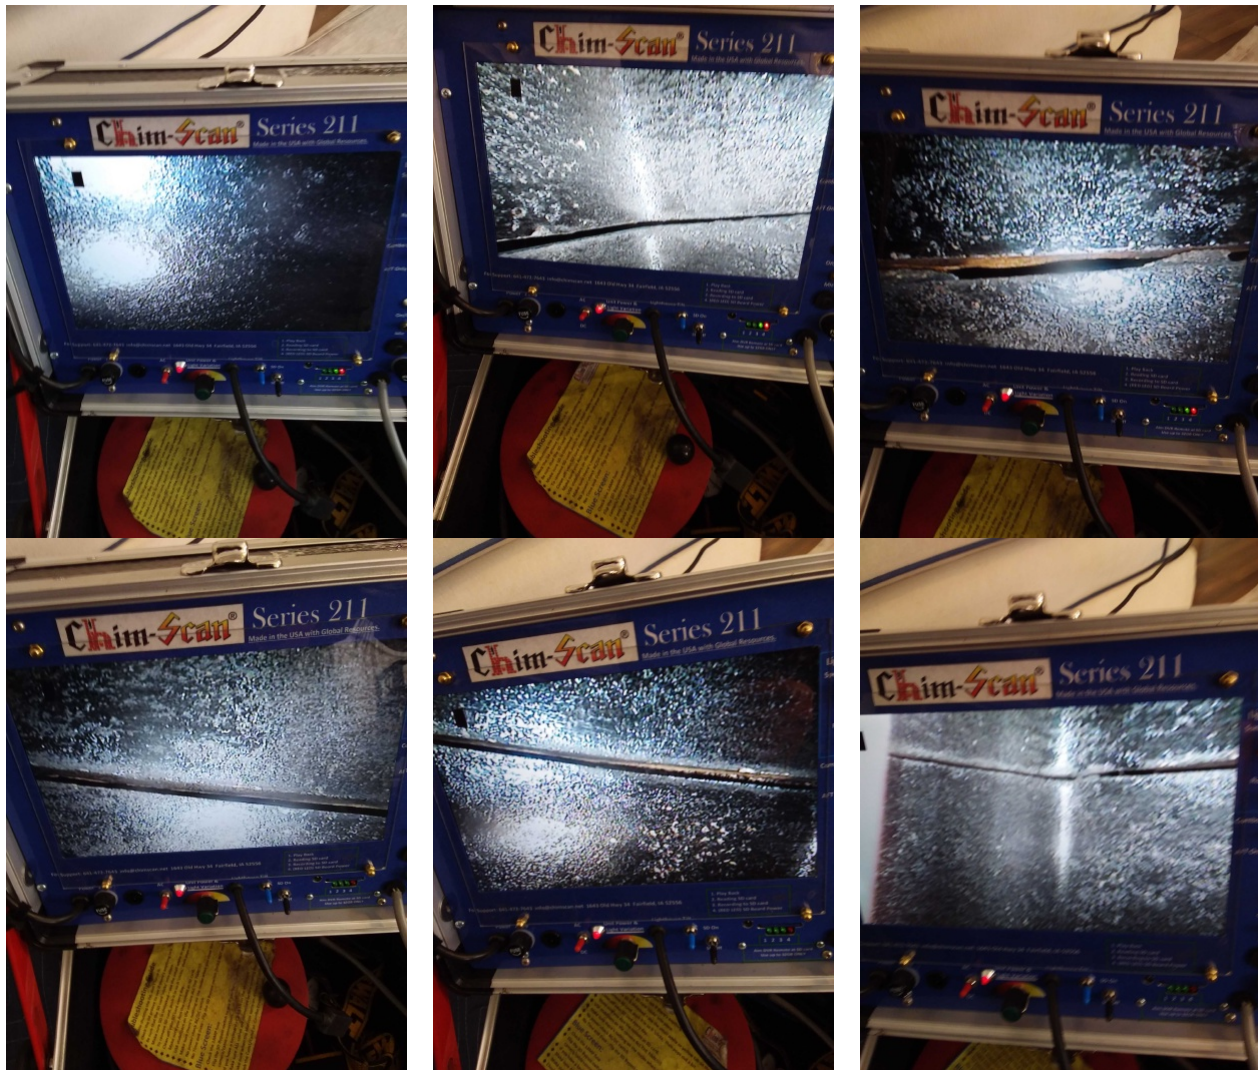
- **Internal flue opening length: 11.25**
- **Chimney cap / spark guard / Top damper: Suitable material condition**
- **Chimney liner presence, condition regarding readily visible defects, holes, cracks, missing mortar joints, spalling, mortar protrusions, and proper alignment: Potential hazard**

The mortar joints between the flue tiles are no longer intact. These missing or deteriorated mortar joints prevent the flue tiles from properly conveying the byproducts of combustion to the exterior of the home.

Flue is coated with stage 3 glazed creosote.

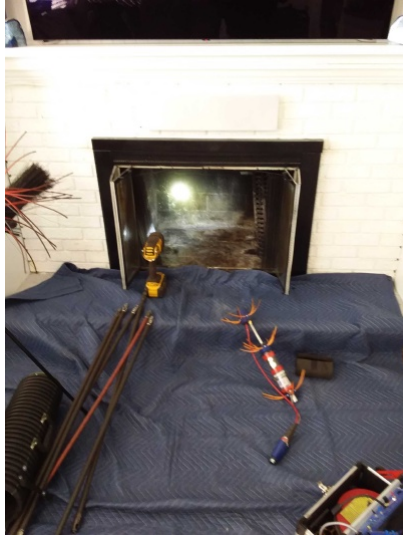
- Hearth extension size - sides of fireplace: 20
- Flue tile sealed at smoke chamber: Does not meet industry standards

The flue tile is not sealed at the top of the smoke chamber. This can allow the byproducts of combustion to go behind the flue tiles and may migrate to areas of the chimney and home not meant to contain them. The potential hazard exists that combustible residue could built up where it cannot be maintained and allow the possibility of a structure fire. This defect could also allow carbon monoxide the enter the home. 2016 NFPA 211 11.2.1.13

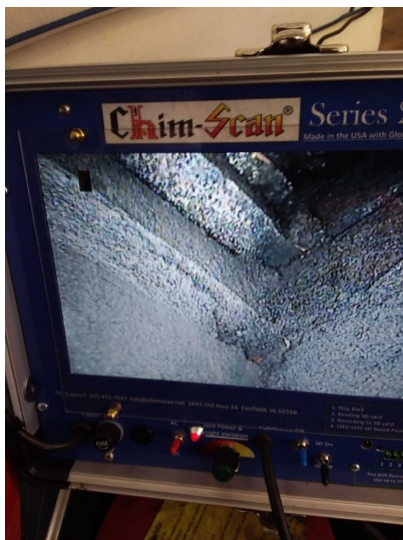
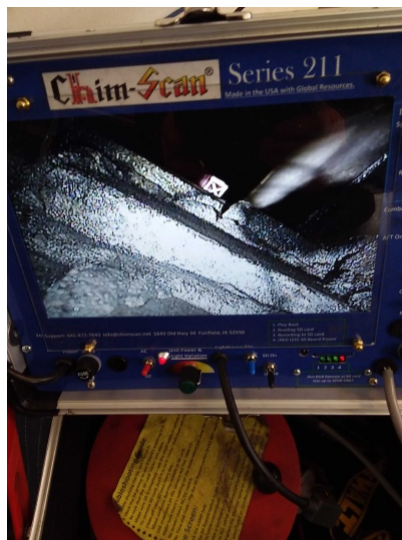
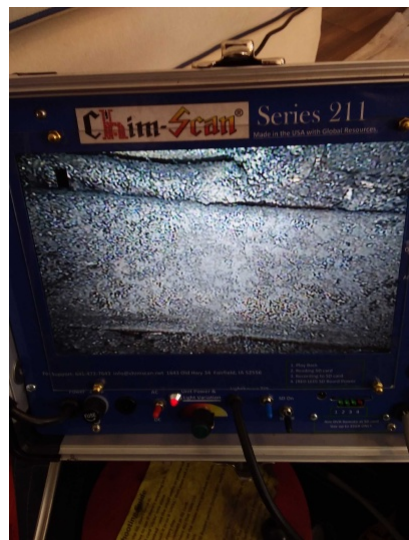
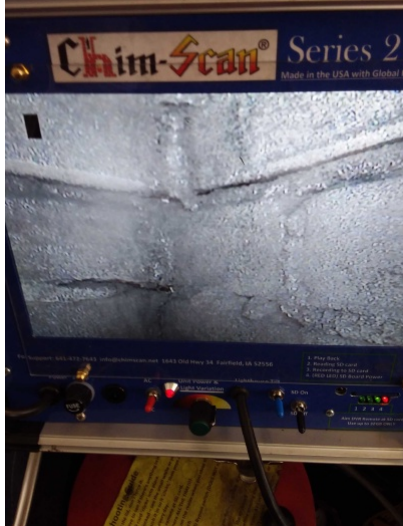
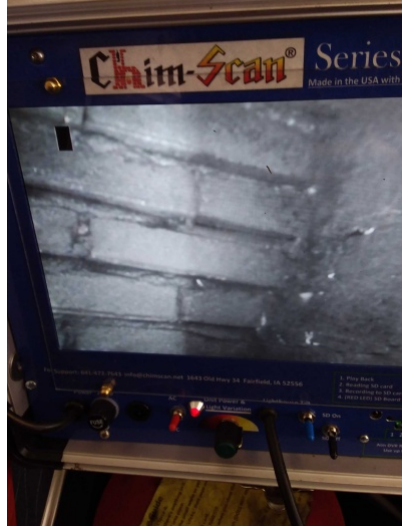
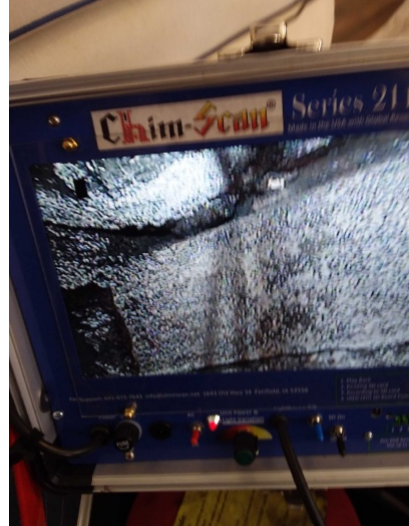
The smoke chamber is a crucial part of the fireplace system and is often the most poorly constructed area of the structure. Most structural fires associated with fireplaces originate in this area. It is imperative that this area be completely sealed and parged smooth. 2016 NFPA 211 11.2.1.13 IRC 2006 2111.S

The smoke chamber walls are not parged smooth. This can cause a chimney to draft poorly. Lack of the parging material may also increase the risk of a structural fire and the risk of the byproducts of combustion migrating into the home. 2016 NFPA 211 11.2.1.13 IRC 2006 2111.S
