Inspection Address: ~~123456789 Dr~~
Inspection Date: ~~March 15, 2022~~

Flue

Main Floor Fireplace

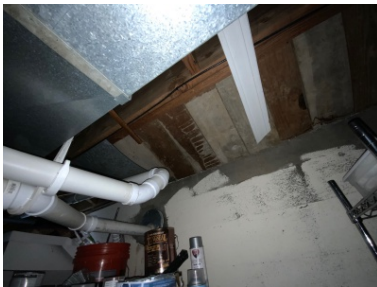
There is significant deterioration in the mortar between the bricks. This can not only allow water intrusion into the chimney and cause potential leaks inside the home, but it also allows water into the chimney which can damage the chimney structure.

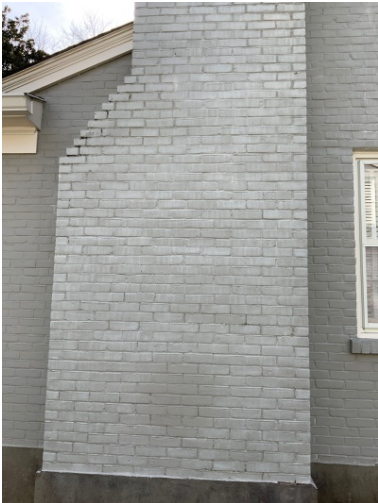
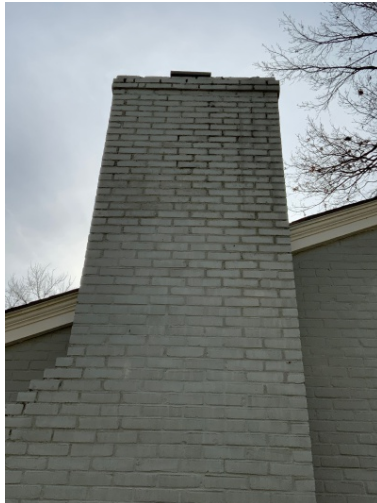
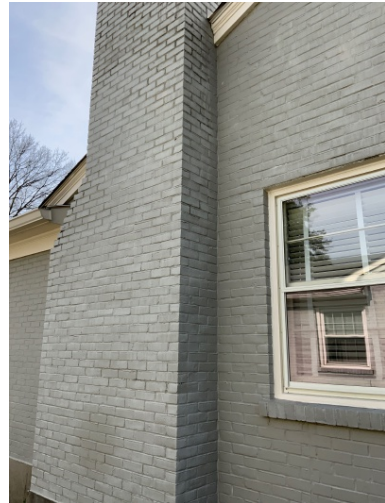
• **Brick / Stone / Chimney walls condition:** Meets industry standards

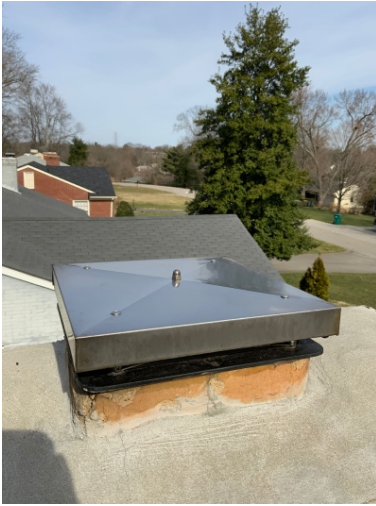
- **Chimney cap / spark guard / Top damper:** Suitable material condition

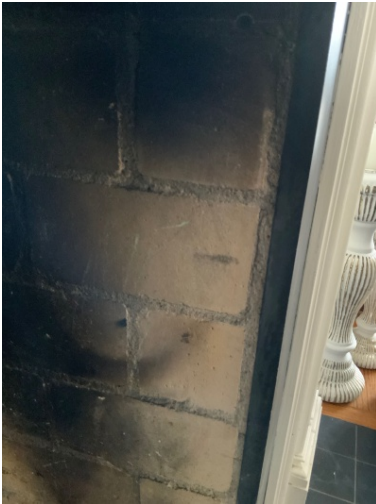
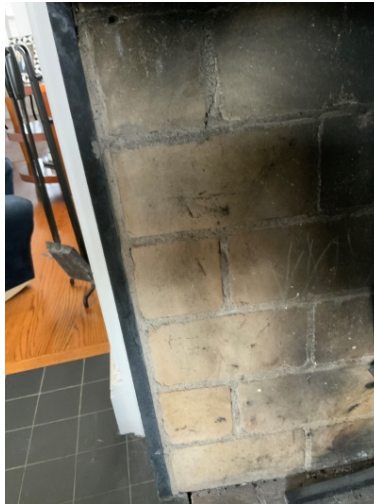
- **The firebox is required to have tight fitting joints at the facing material, lintel and hearth extension:** Meets industry standards
